APRIL 2002 EPICENTRAL EARTHQUAKE IN TBILISI, GEORGIA

SUMMARY

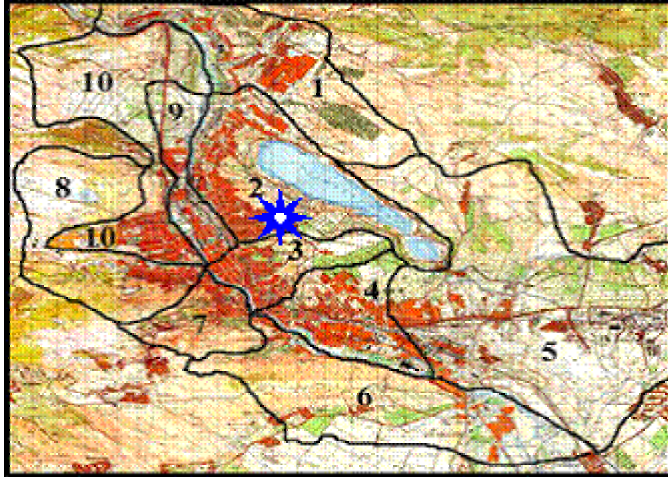
Fig. 2. Map of the city with the epicenter and districts

The capital of Georgia, Tbilisi, with population of 1.5 million is one of the oldest large cities in the world. It is situated on terraces of the river Mtkvari with abrupt coasts that caused linear configuration of the city along the river with sizes about 40x4 km in plan (Fig. 2).

In Tab. 1 types of buildings are: 1: 1-3 story with brick walls; 2: 4-8 story of brick; 3: 5-9 story large-block; 4: 5-12 story large-panel; 5: 5-16 story prefabricated & cast in place RC frame; 6: 5-16 story cast in place reinforced concrete. Numbers of district correspond to shown in Fig. 2.

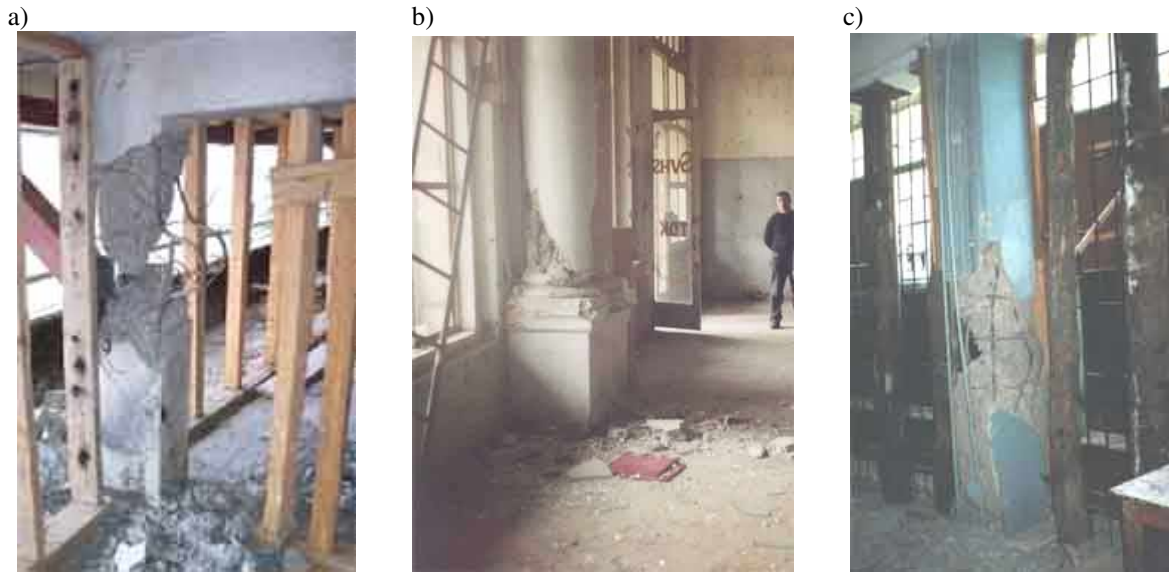
Fig. 3. Damage of columns. Inst. of Mathematics (a); Residential building in Kostava str. (b); Column of first RC floor of large-block building in Nadzaladevi District (c).

Some reinforced concrete frame buildings designed for intensity VII, received severe damages. The main reason was the usage of low-quality materials, errors in design (Fig. 3).

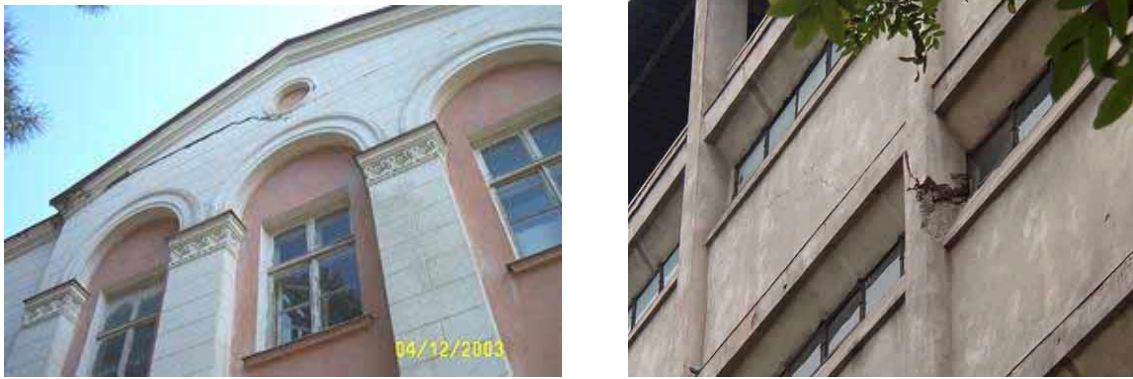
Fig. 4. Damaged brick building of hospital, A.Kazbegi str (left); Damaged column. State historical museum (right).

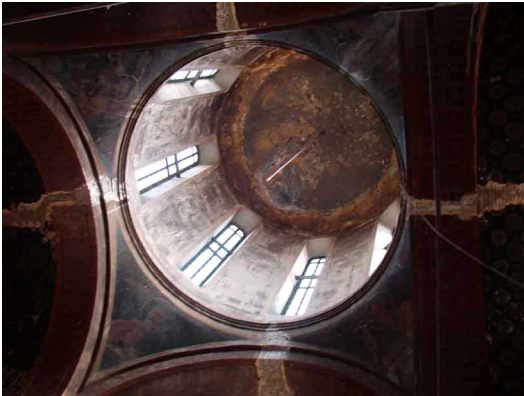
Fig . 5. Repaired symmetrical cracks, 300 Aragveli church. Fig. 6. Shifted and overturned monuments in grave yards

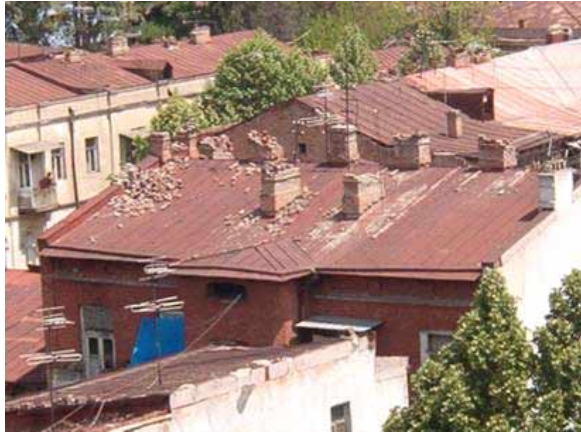
Fig. 7. Failed chimneys in Chugureti District

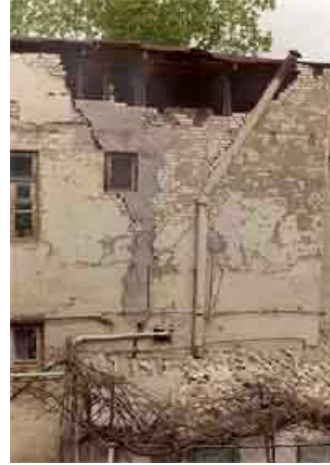
Fig. 8. Failed brick wall

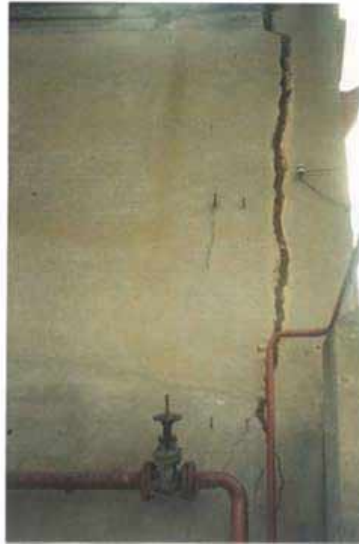
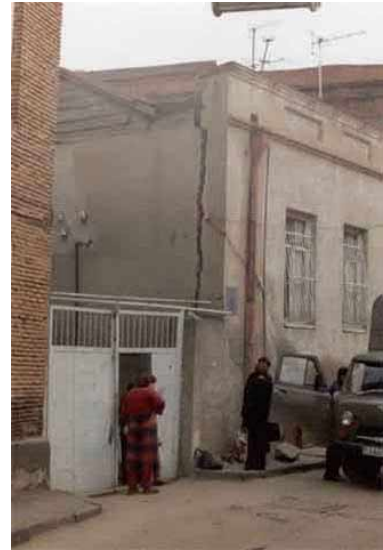
Fig. 9. Alexander Dumas str.
Before the EQ, March 2002
(left); after the EQ (right)

One of important factors influencing on the damage effect (and not presented in macroseismic scales), is earthquake duration. Fortunately, duration of the Tbilisi earthquake was short that played positive role in response of all types of buildings, in particular, of buildings having initial damages (Fig. 9, 10). For transversal component the bracketed duration is 0.2s (calculated between the first and the last excursions of 5% of PGA level); the uniform duration is 0.1s (calculated as the total time during which the acceleration is larger then a value 5% of PGA); significant duration is 2.4s (calculated as the interval of time between the 5% and 95% thresholds of the total accumulated Arias intensity).

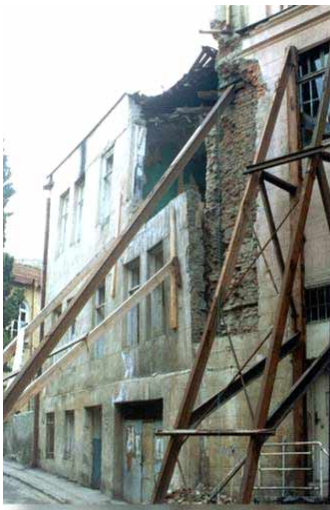
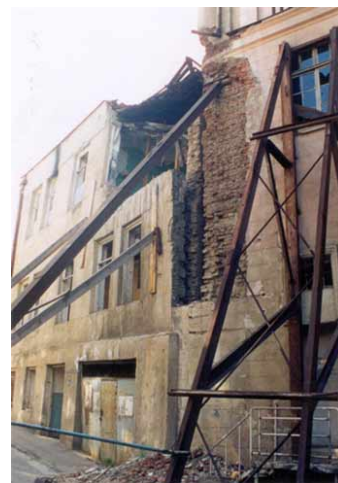
Fig. 10. Chaikovski str. Brick
building before the EQ, March
2002 (left); after the EQ
(right)

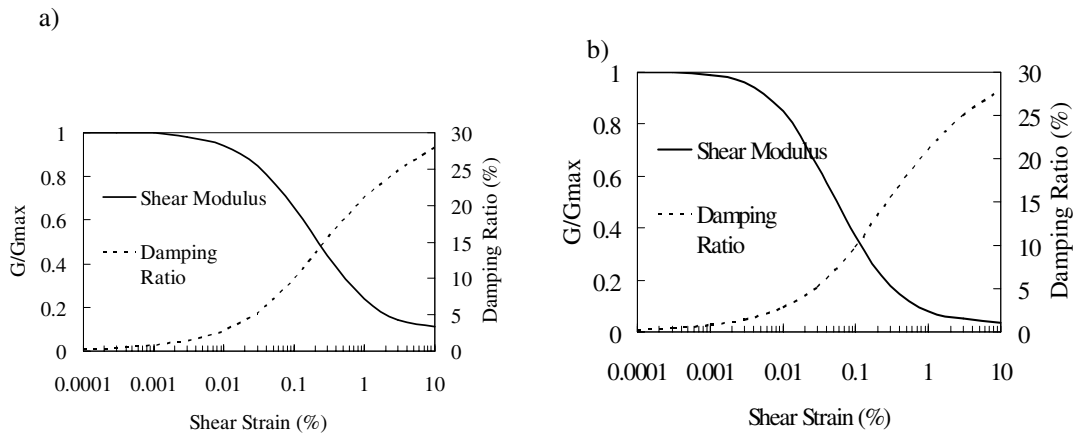
Figure 12. Dependences of soil parameters used in calculations: a) Modulus for clay, Seed, Sun (1989) upper range, damping for clay and sand, Idriss (1990); b) Modulus for sand, Seed, Idriss (1970) upper range and damping for sand, Idriss (1990).

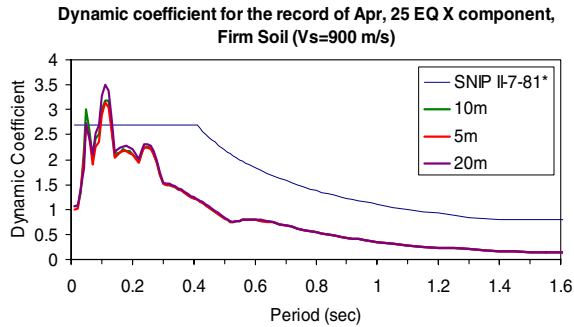
Figure 19. Dynamic coefficient curves for soft, average and firm soil at different layer thickness; normative curve from seismic Code SNIP II-7-81*.
